# ***MEADOWLARK PROPERTY INSPECTIONS***

## **Property Inspection Report**

0 Medford Dr., Medford, OR 97520  
Inspection prepared for: John Doe  
Real Estate Agent: -

Date of Inspection: 8/29/2024 Time: 9:00 AM  
Age of Home: 2002 Size: 2316  
Weather: Sunshine

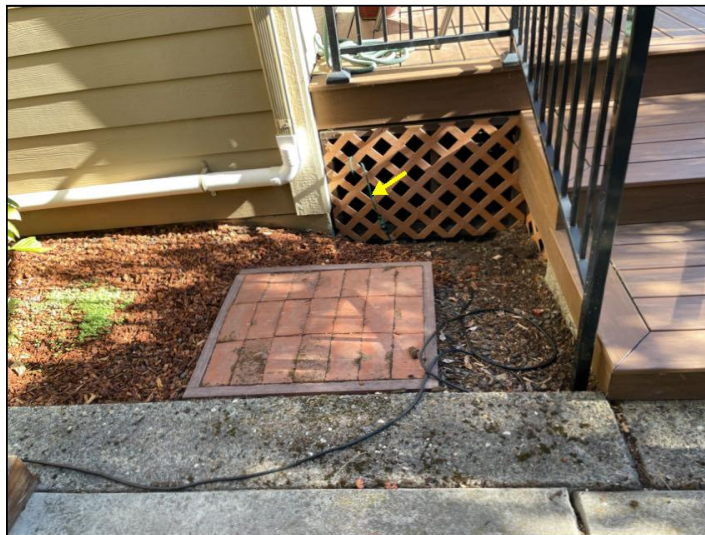
Extension cords were noted on the exterior of the home. Extension cords should not be used as permanent wiring, extension cords are made for temporary use and using them for permanent wiring can be a fire hazard.

Modification or addition is generally considered an upgrade which should improve safety or efficiency.

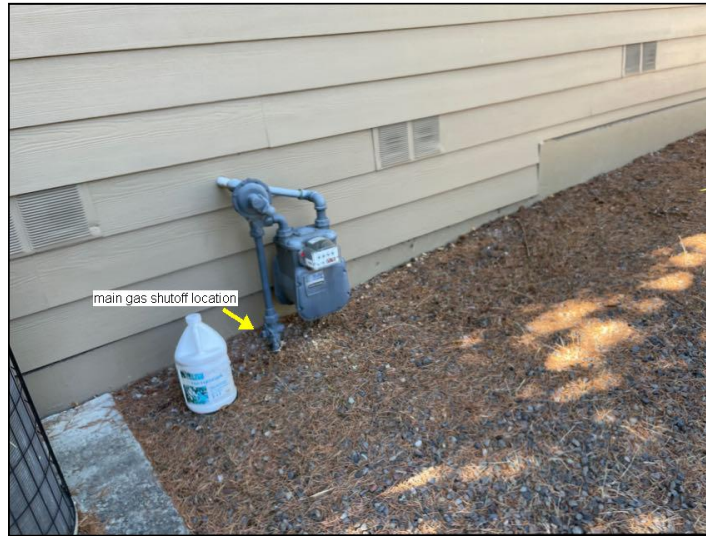
- A gas main shut-off wrench was not discovered. In an emergency it is important to know where the shut-off spade is and have a shut-off wrench located at this gas main.
- Modification or addition is generally considered an upgrade which should improve safety or efficiency.

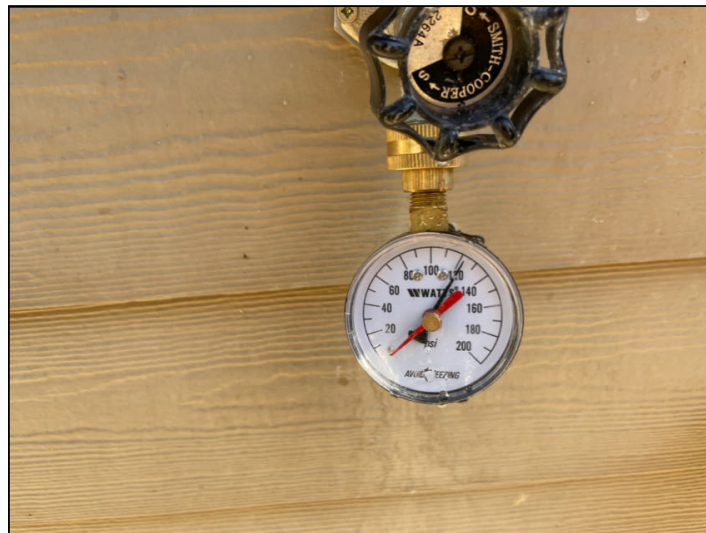
120 psi of water pressure was measured. High pressure can cause pipes to leak. Installation of a pressure regulator by a qualified licensed contractor is recommended.

Correction or modification decreases the probability of continued and excessive deterioration.

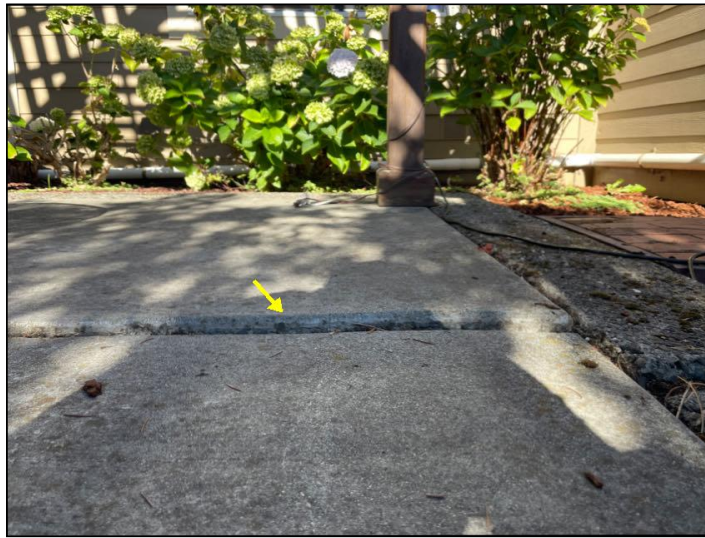
The patio at the pergola had an uneven section of concrete that could prove to be a trip hazard. Concrete replacement or concrete grinding is recommended for the safety of the occupants.

Modification or addition is generally considered an upgrade which should improve safety or efficiency. The opinion of a qualified licensed concrete contractor is recommended.

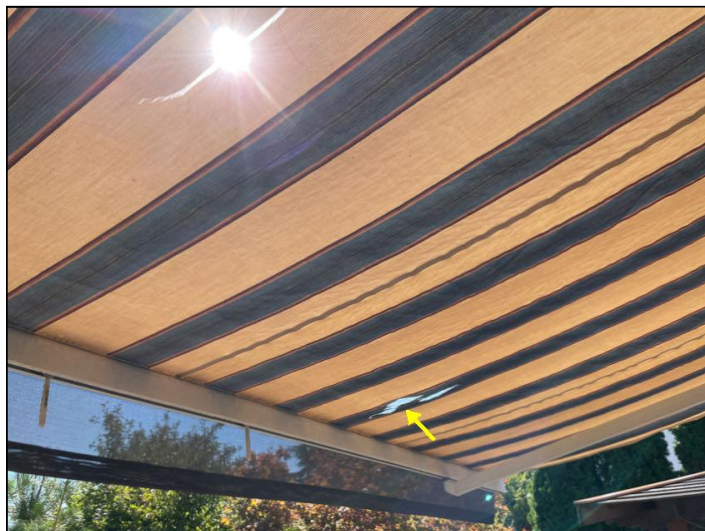
- The entry porch roof was in serviceable condition.
- The back deck awning was torn and should be replaced. The motorized retractable awning did not function from the nearby switch.

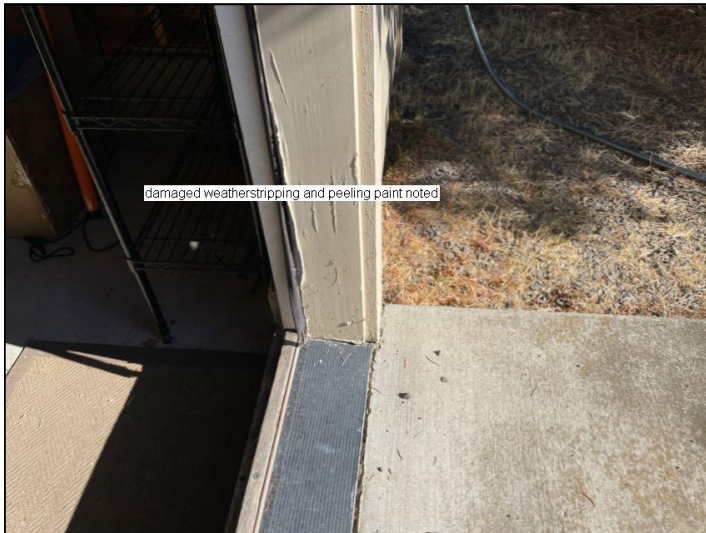
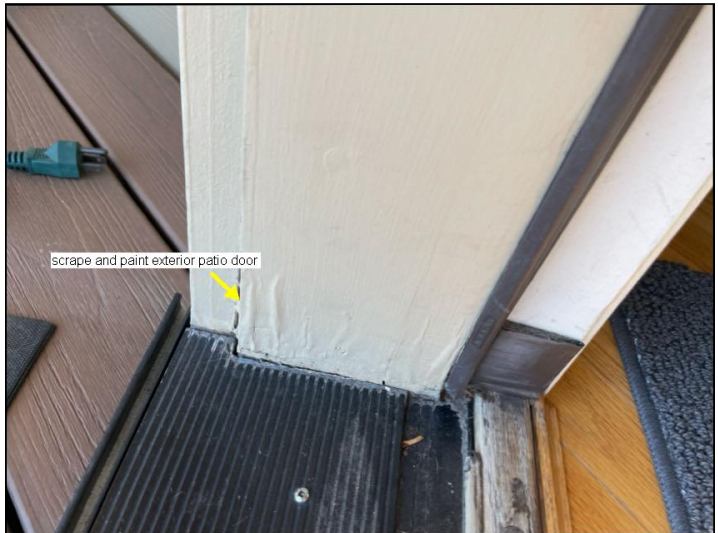
The crawlspace exterior door frame had peeling paint and damaged weatherstripping. New paint and weatherstripping was needed to prevent deterioration. The back patio door frame paint was peeling and should be scraped and resealed to prevent wood deterioration.

Correction or modification decreases the probability of continued and excessive deterioration.

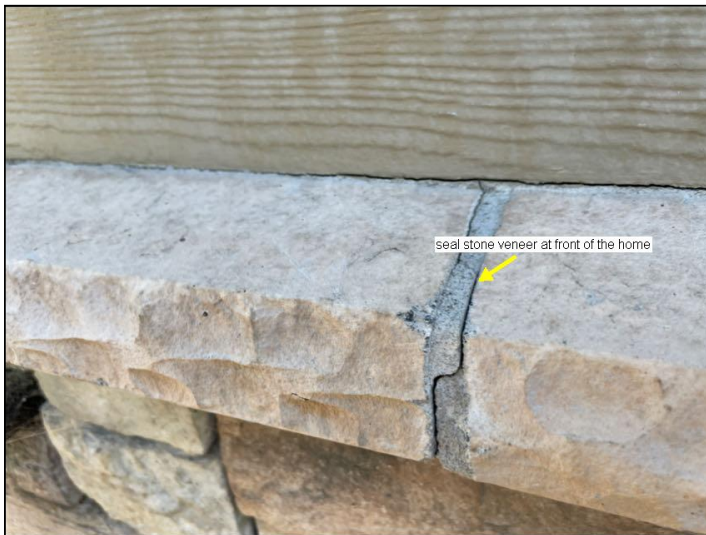
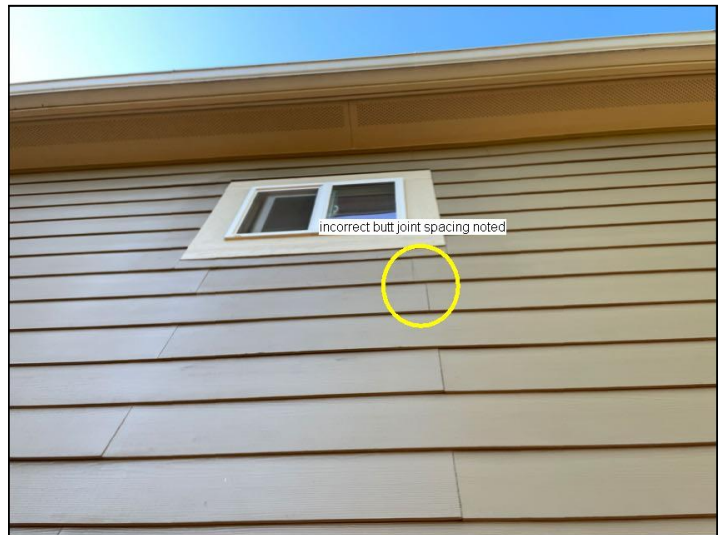
- The stone veneer should be re-grouted or sealed where needed to prevent water intrusion.
- Incorrect staggering of lap siding joints was observed on the left side of the home. Butt joints in adjacent courses should be spaced apart by at least two stud bays to prevent water intrusion.
- Correction or modification decreases the probability of continued and excessive deterioration.

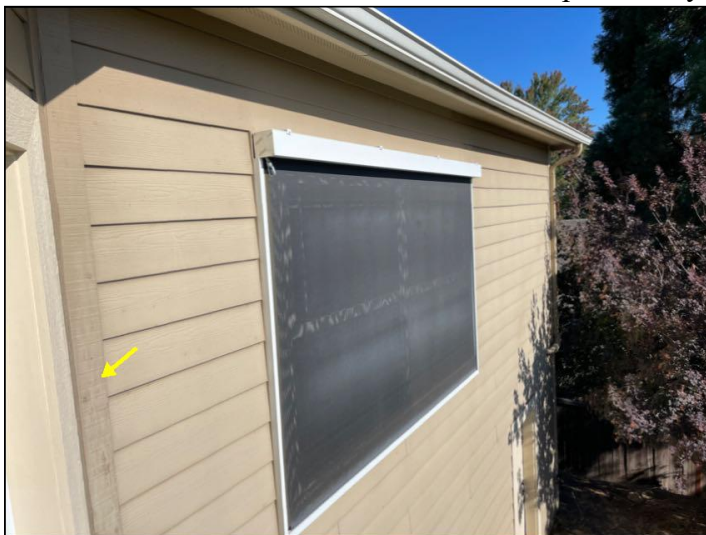
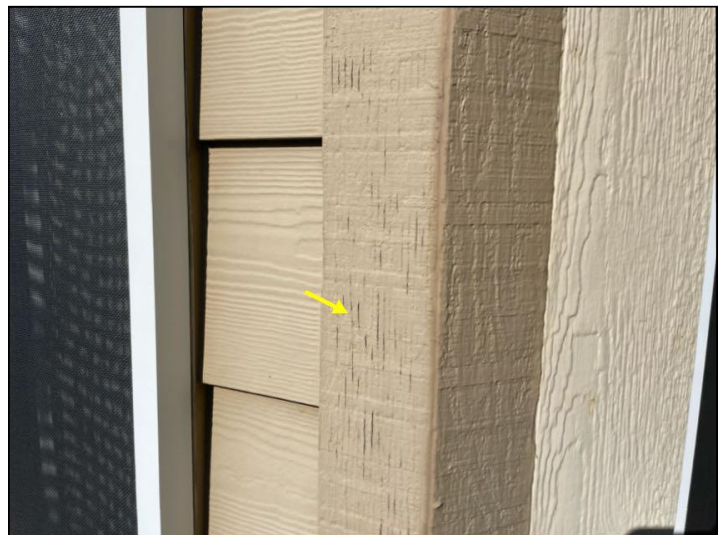
- The paint was in serviceable condition except where noted.
- (P)
- Cracked paint was observed on the corner trim located at the back of the house. Repainting the wood trim is recommended to prevent deterioration.
- Correction or modification decreases the probability of continued and excessive deterioration.

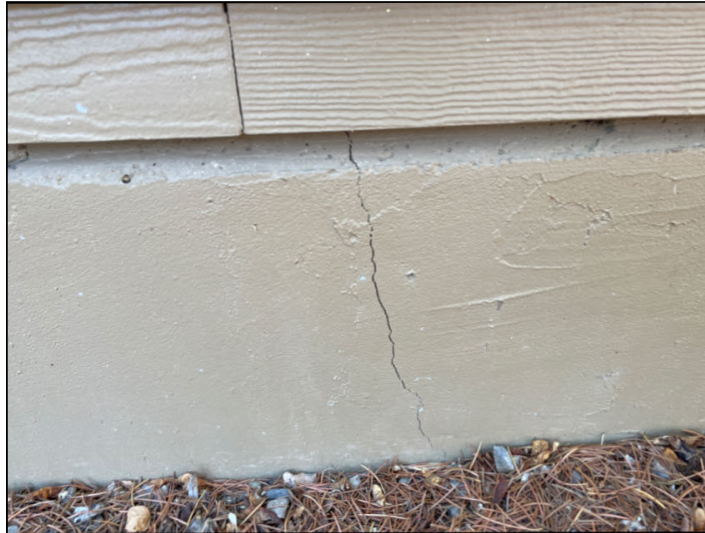
- (P)
- Hairline vertical cracks were observed on the exterior. Cracks in the foundation walls should be sealed with the appropriate caulking to prevent water from causing further damage.
- Correction or modification decreases the probability of continued and excessive deterioration.

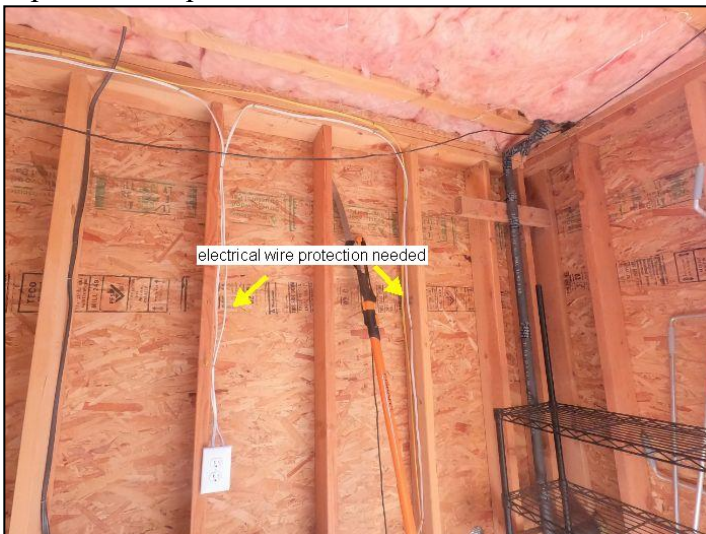
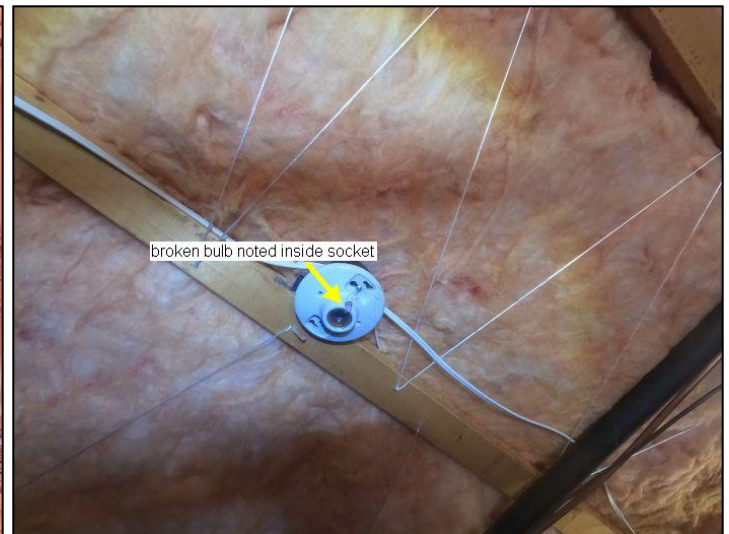
- Most wiring was covered by insulation and was not visible for inspection.
- (U)
- The exposed wiring within 7 feet from the floor should be covered or protected inside conduit for increased safety.
- A broken light bulb was observed inside the socket at the sub area ceiling. Safe removal of the broken bulb was needed.
- Modification or addition is generally considered an upgrade which should improve safety or efficiency. The opinion of a qualified licensed electrical contractor is recommended.

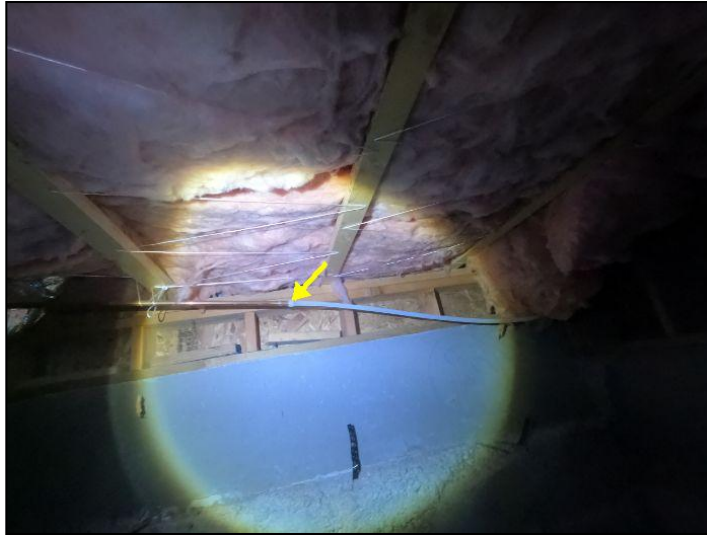
- Copper supply pipes noted.
- Pex supply piping noted.
- Acrylonitrile-Butadiene-Styrene "**ABS**" waste and vent pipes noted.
- The supply lines were covered by insulation and not visible for inspection.
- The visible portions of drain and waste pipes were serviceable at time of inspection.
- (E)
- Some sections of the supply lines were not insulated. Insulation plays a crucial role in protecting your pipes from freezing during winter. It acts as a barrier, preventing heat transfer and maintaining the temperature inside the pipes.
- Repair, alteration or replacement usually improves the efficiency of the component or system.

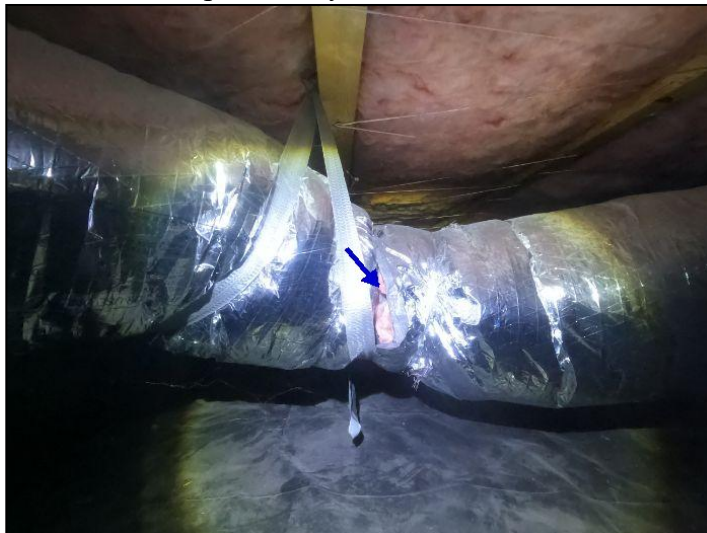
- The visually accessible areas of ducting were in serviceable condition except where noted.
- (P)
- One section of ducting insulation needed to be taped up to prevent rodent access.
- Correction or modification decreases the probability of continued and excessive deterioration.

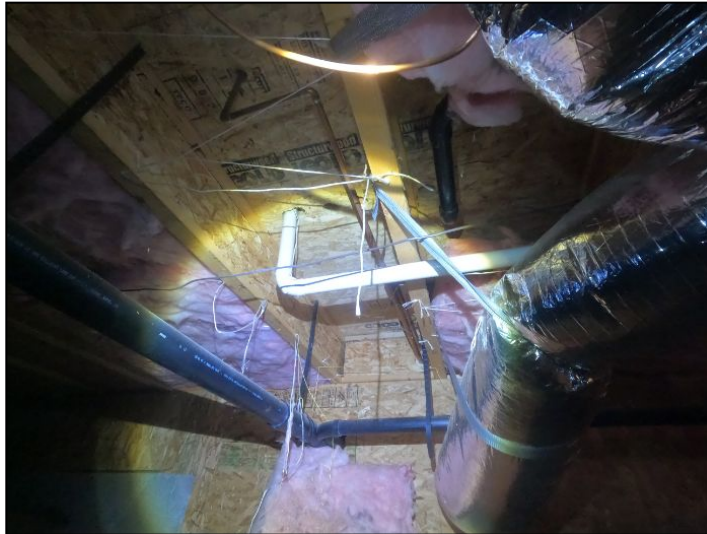
One section of insulation was pulled down under the kitchen where it appears repairs were made. Re-insulate this area for increased energy efficiency and protection of the copper water supply lines.

- Repair, alteration or replacement usually improves the efficiency of the component or system.

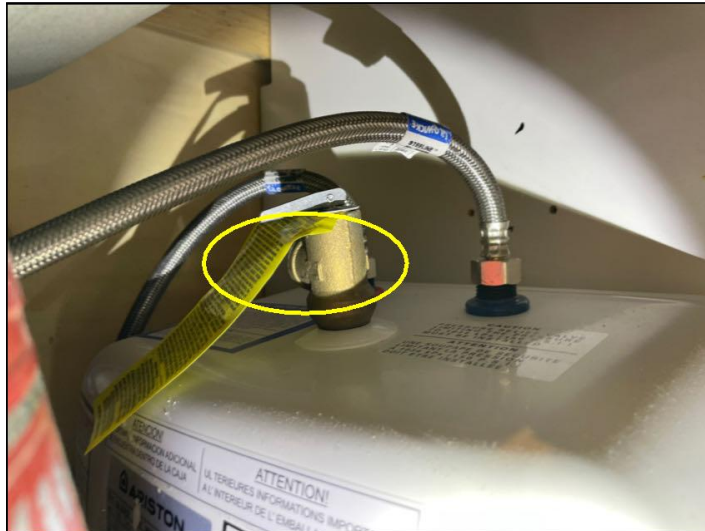
No **TPR valve** extension pipe present on the kitchen water heater. This is a scalding hazard and could cause water damage under the sink. The TPRV discharge tube should terminate in a drain pan or at the exterior of the home.

It is recommended that the finding be reviewed, and corrected as needed by a qualified licensed plumbing contractor.

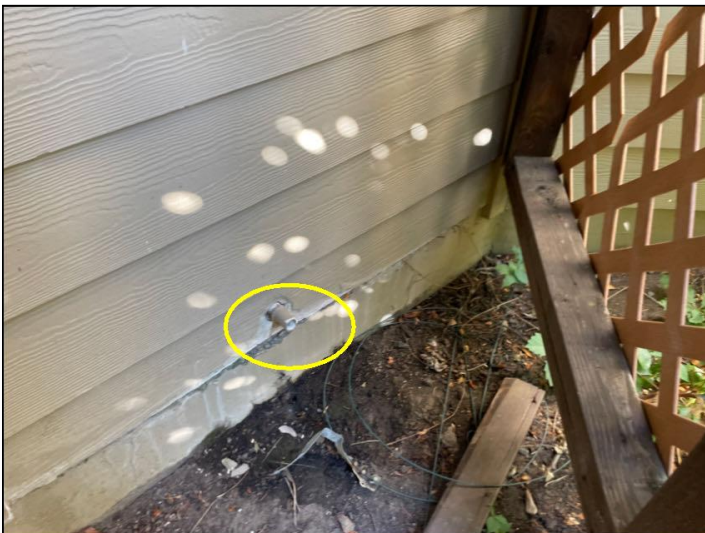
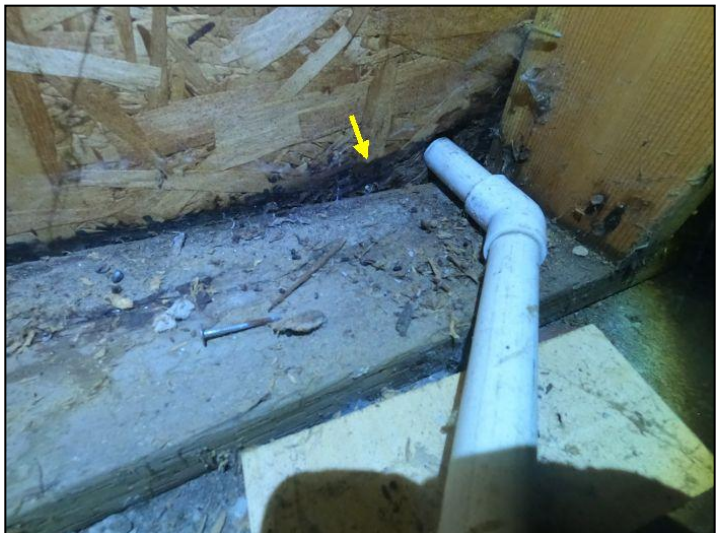
The condensate line was creating water damage to the shear wall plywood under the back deck. The condensate line should be extended further away from the exterior wall to prevent further damage.

Corrections by a qualified licensed contractor is recommended.

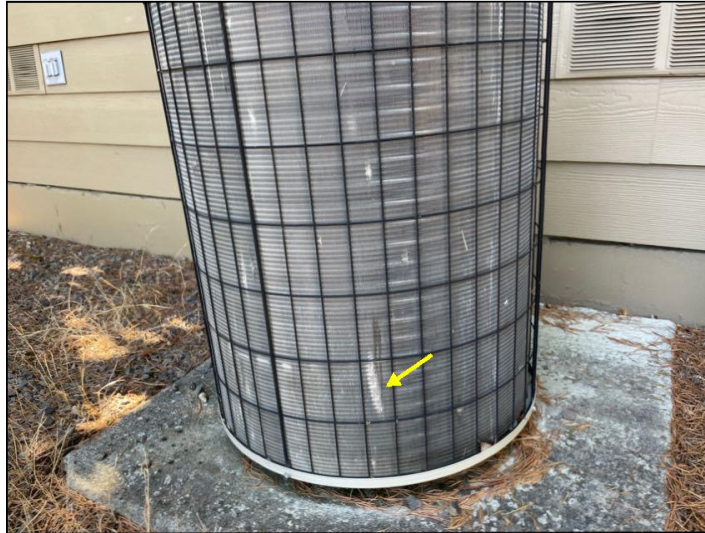
- The condenser was 21 years old and was approaching or past its serviceable lifespan. The average lifespan of these units is approximately 15 years. The unit was functional at the time of inspection. Annual **HVAC** service contract is recommended.

- The condenser fins were starting to deteriorate. The fins need to be in good condition to allow the proper airflow through the unit.

- Repair, alteration or replacement usually improves the efficiency of the component or system.

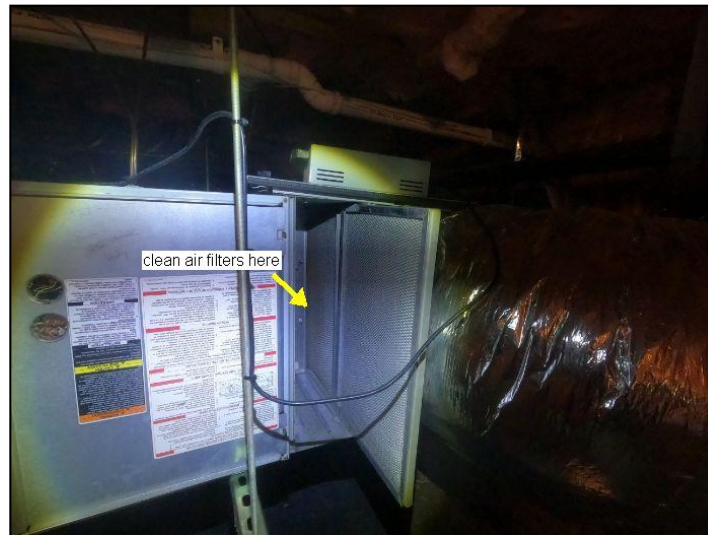
The furnace electronic air filter located in the sub area was dirty. Filters help clean the house air, making the environment more pleasant. Filters also clean the air before it passes through the blower and heat exchanger. This helps to keep these furnace components working efficiently. It is recommended to change the filter and have annual maintenance and inspections performed.

Repair, alteration or replacement usually improves the efficiency of the component or system.

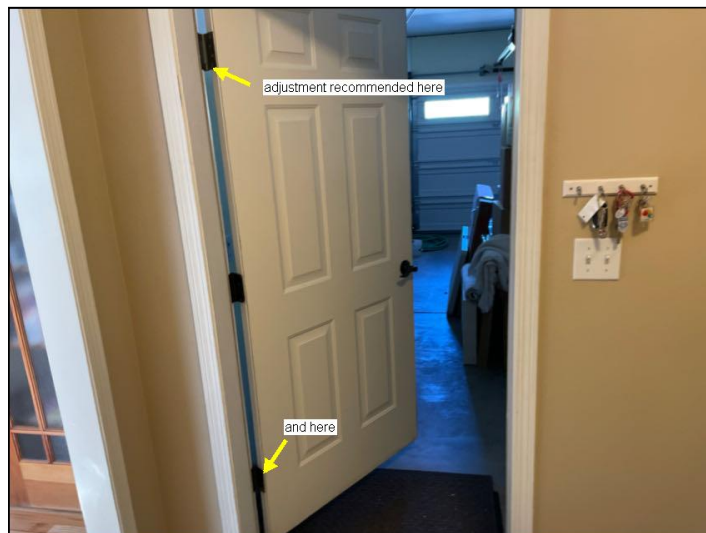
The automatic closure device did not close the garage/house door properly. This could allow a fire or carbon monoxide to enter the home. Although not required, I recommend adjusting the hinges to allow for proper closure of the door.

Modification or addition is generally considered an upgrade which should improve safety or efficiency.

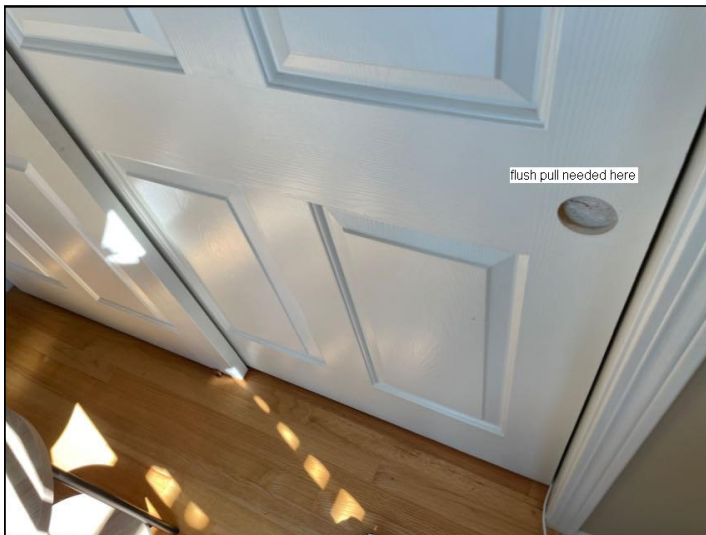
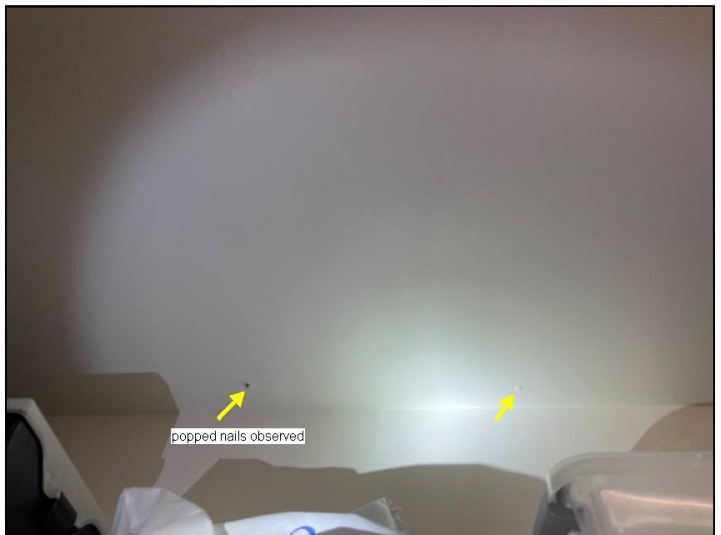
- The closets were in serviceable condition during the inspection.
- (E)
- The bi-pass door flush pull was missing at the back bedroom closet. Installation of a new flush pull was needed.
- Repair, alteration or replacement usually improves the efficiency of the component or system.
- (A)
- Popped nails were observed on the closet ceiling in the back bedroom and primary bedroom. A nail pop occurs most often when drywall or wooden structural material (studs, joist, trusses) dries out and shrinks slightly, which causes the mounting nails or screws to protrude.
- Maintenance, alteration or repair could be expected to improve component appearance and may decrease deterioration.

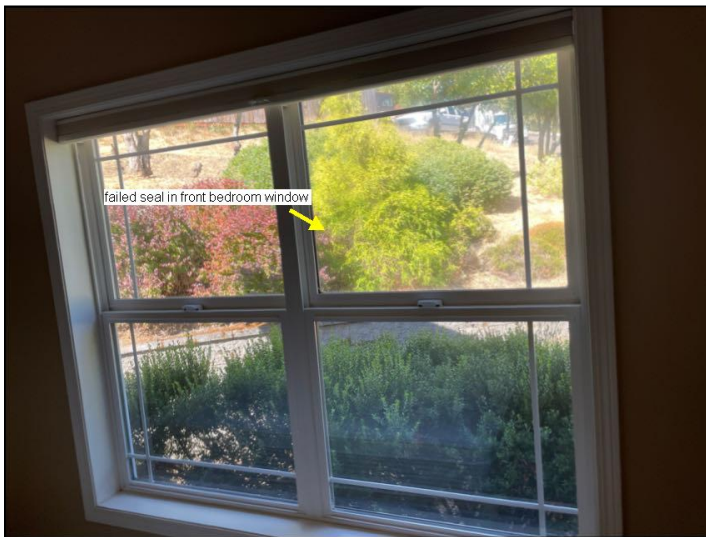
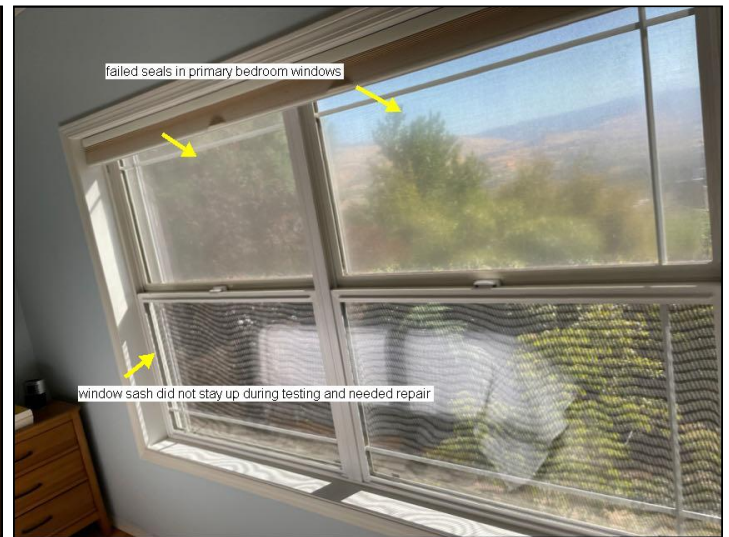
One front bedroom window and two primary bedroom windows showed signs of a broken gas seal between the panes of glass. Repairs or replacement will provide energy savings and prevent a hazed window from limiting the view.

It is recommended that the finding be reviewed, and corrected as needed by a qualified window company.

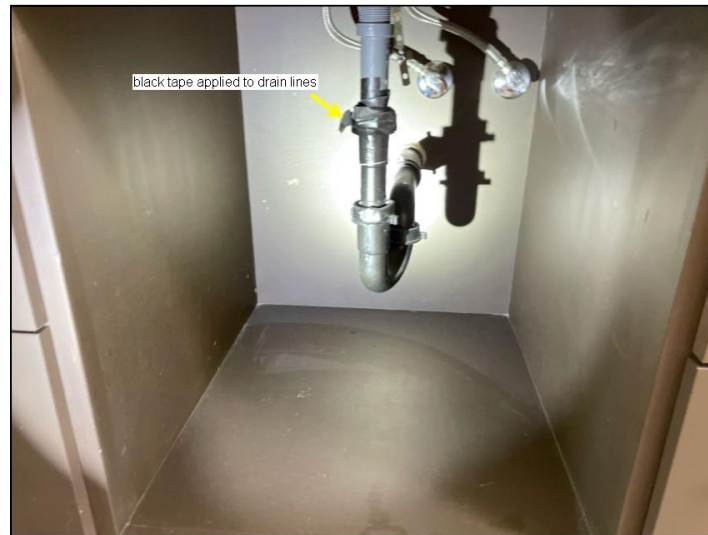
• Black tape had been applied to the plumbing drain lines under the primary bathroom sinks. It appeared that the tape was applied for aesthetics since the plumbing was exposed. If the tape had been applied to stop leaks, the tape should be removed and proper repairs should be made. No leaks were detected during testing.

- The significance of the finding is uncertain. Further study by a qualified licensed contractor is advised.

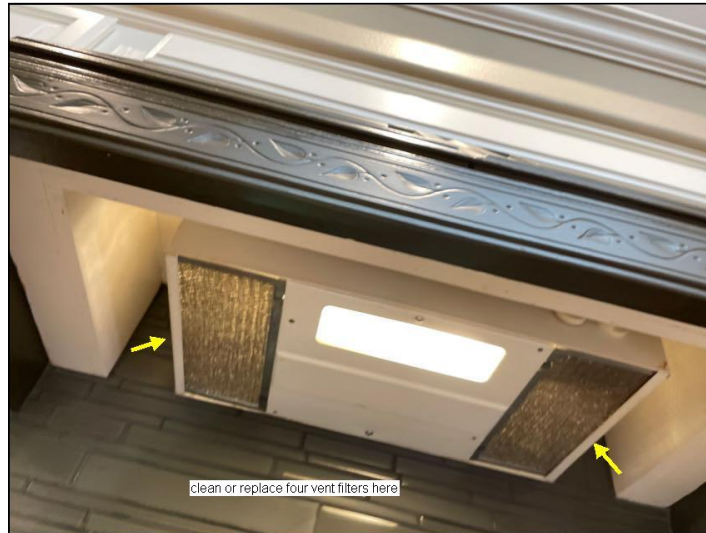
- (U)
  - The vent filters were greasy. Recommend cleaning the filter regularly for fire safety and efficiency of the motor.
  - Modification or addition is generally considered an upgrade which should improve safety or efficiency.

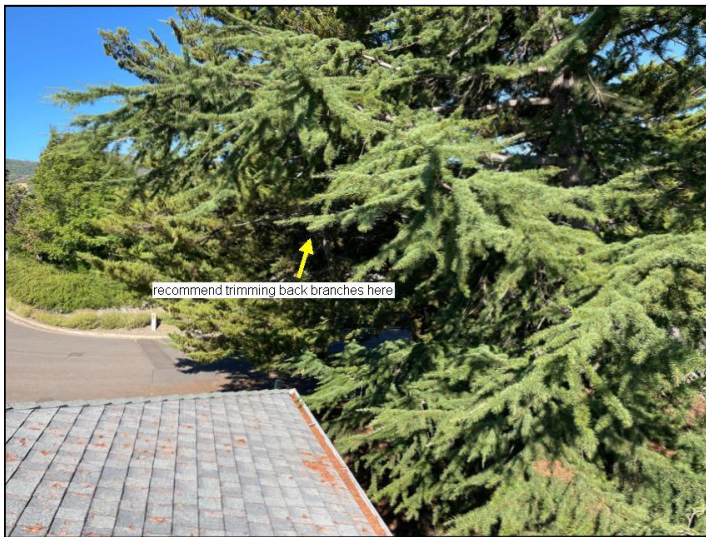
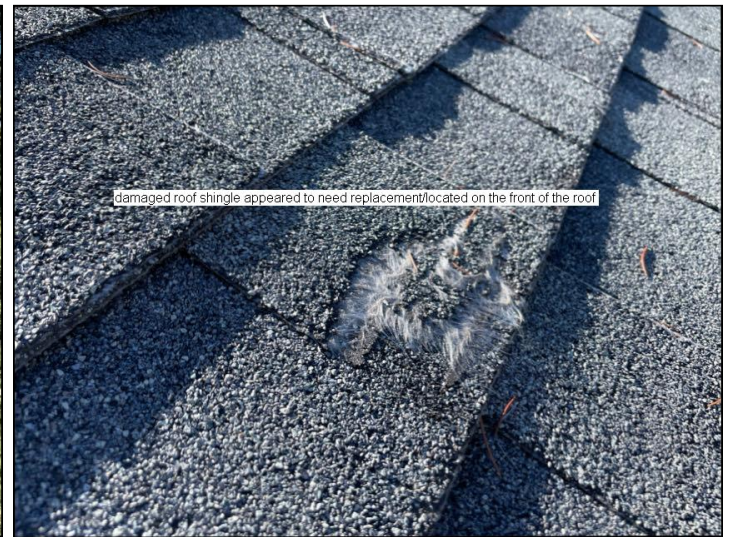
Roof shingle granule loss was observed and at least on roof shingle appeared to need replacement. The roof was approaching the end of its serviceable lifetime and should be evaluated further. No leaks were detected at the time of inspection.

It is recommended that the finding be reviewed and corrected as needed by a qualified licensed roofing contractor.

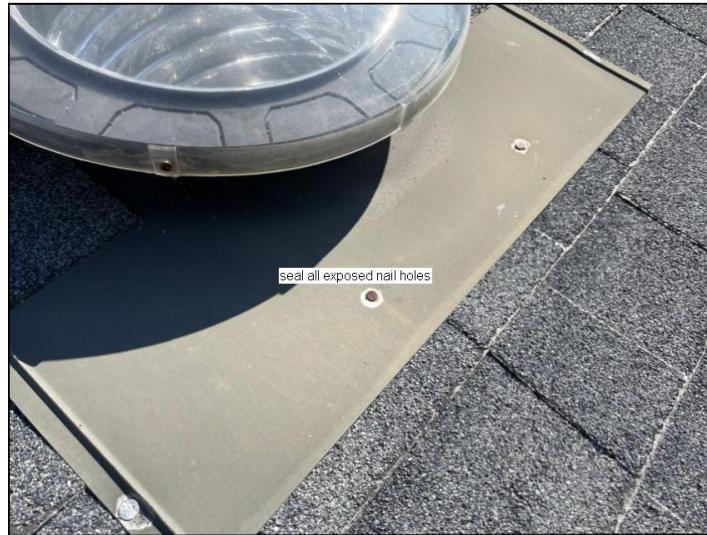
- Exposed nail heads were observed on several of the flashings. All nail heads need to be sealed to prevent leaks.

- Correction or modification decreases the probability of continued and excessive deterioration.

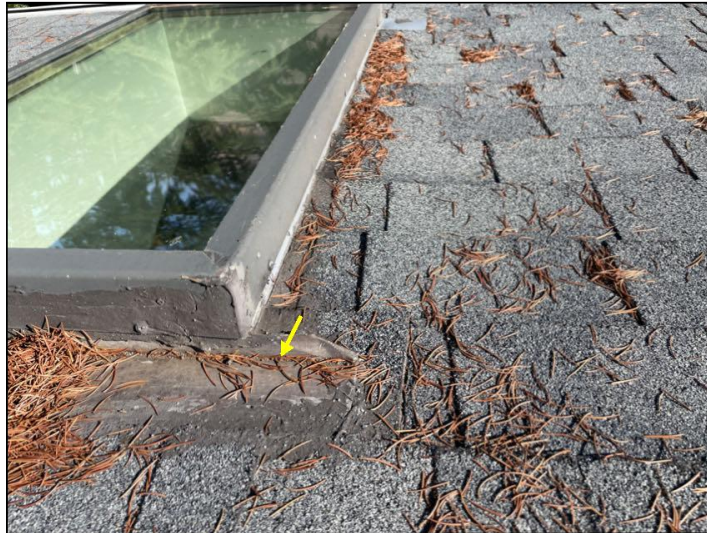
- The skylights appeared to be serviceable during the inspection.
- (M)
- A mastic seal had been applied to the primary bathroom skylight which may indicate past leaks. No evidence of water damage was found at the time of inspection.
- Monitor the situation on a regular basis. Corrections by a qualified licensed contractor, if and when necessary, are recommended.

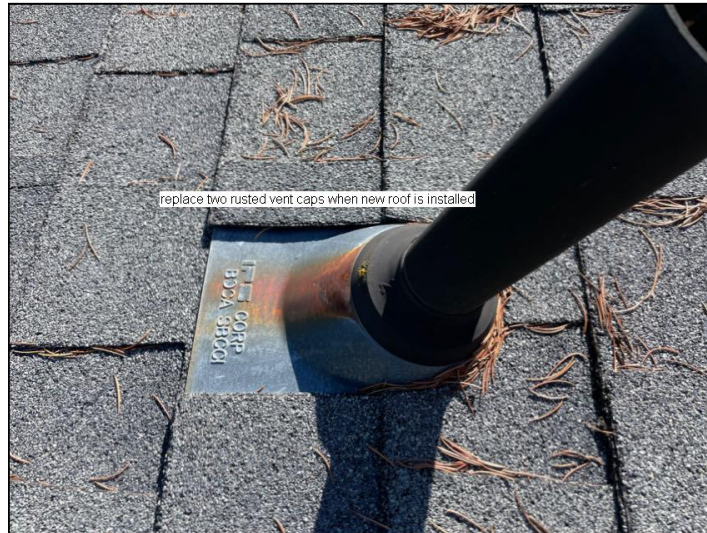
- (E)
- Rusty vent caps were noted and need to be replaced when a new roof is installed.
- Repair, alteration or replacement usually improves the efficiency of the component or system.

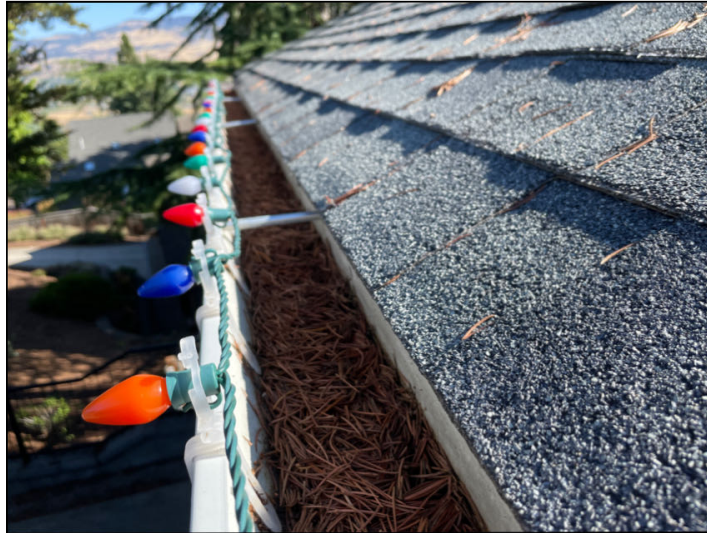
- The gutters and downspouts appeared serviceable during the inspection. The gutters were not tested.
- (P)
- Debris was observed inside the gutters. Functional gutters will control the flow of rainwater and protect the roof, walls and foundation from water damage.
- Correction or modification decreases the probability of continued and excessive deterioration.
